## Disk brake boosters – drain grommet removal

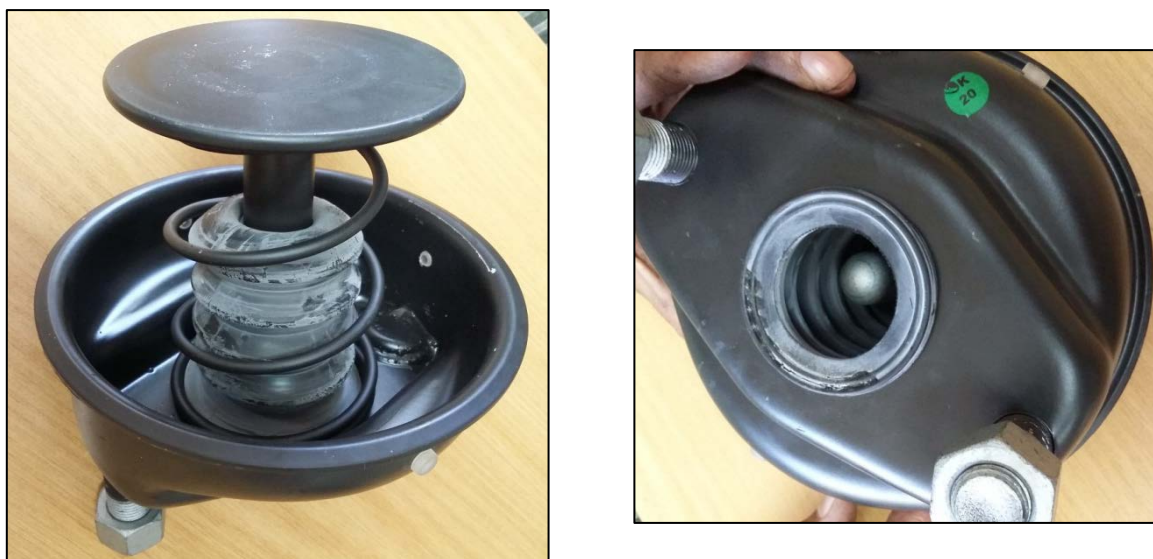
BPW disk brake boosters are different to that of drum brake boosters. The service section of the disk brake booster contains a bellow as indicated in Figure 1. This bellow acts as a seal to protect the disk brake calliper from moisture and dirt. The front of the service section has a rubber O-ring, which is part of the bellow (see Figure 2) and seals the unit when it is tightened to the disk brake calliper.

Figure 1: Service section of the disk brake booster

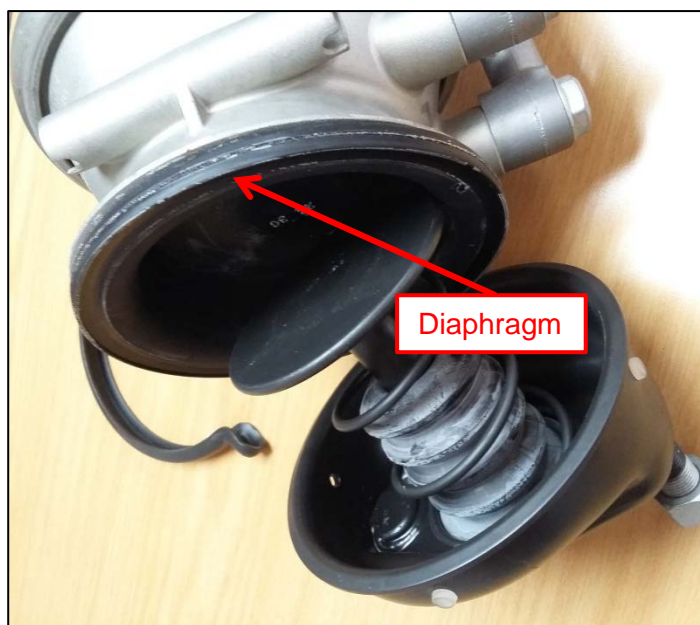
In addition the service section is sealed off to the rest of the brake booster via the diaphragm, see Figure 3.

Figure 3: Diaphragm sealing off the service section

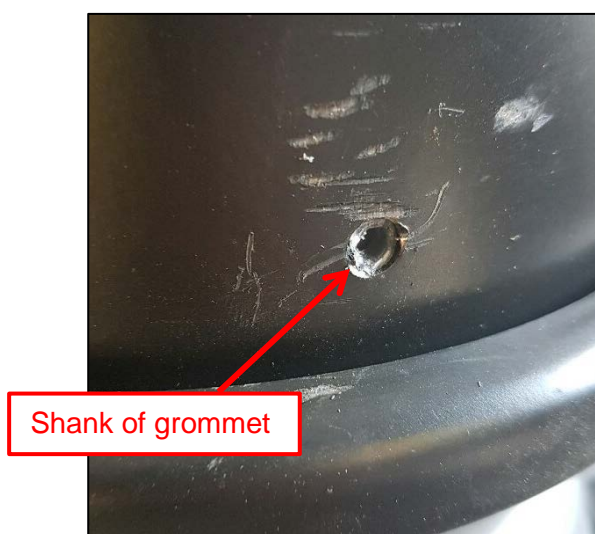
Incorrect removal of the drain grommet, as shown in Figure 6, which shows that the shank of the grommet is still within the drain hole. The shank can be pushed into the service part of the brake booster. This will cause scuffing to the diaphragm with every brake application and release, resulting in premature diaphragm failure and consequential brake failure. It is always important that manufactures instruction are adhered to, in order to prevent future failures.

Figure 6: Left over piece of grommet in the brake booster

It is important that the drain grommet be removed correctly without damaging them. This is done by using a flathead screwdriver and carefully prying the grommet loose. Care should be taken not to damage the paint around the drain hole as the paint acts as a protective coating to the housing of the air cylinder.
